## Transit Damage and Hot Rolled Steel

### Hot Rolled Steel

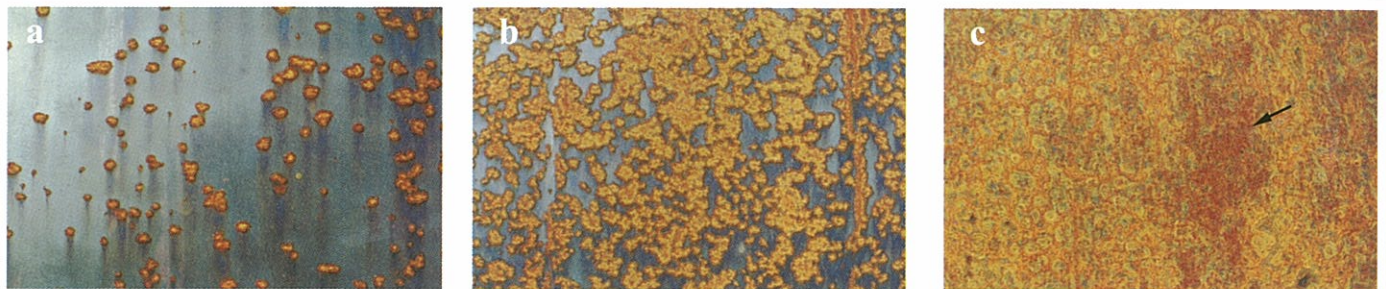
As mill scale is lost, rusting begins (Fig. 2a). The initial rust is a hydrated ferric oxide, with a formula approximating  $\text{FeOH}_3$ . As the rust ages, the oxygen content increases, approaching the formula  $\text{Fe}_2\text{O}_3$ . During this process, the light orange-brown color of fresh rust darkens to a reddish, dark brown (Fig. 2b-c). The geological name for  $\text{Fe}_2\text{O}_3$  is hematite, and this is the most usual form in which iron is found in nature.

Fig. 2 (a) A magnetite coating on hot rolled sheet, with fresh rust breaking through; (b) Hot rolled surface, about 60% covered with fresh rust; (c) Hot rolled steel, with all the original magnetite lost. Rust is beginning to darken where arrowed, to form hematite.

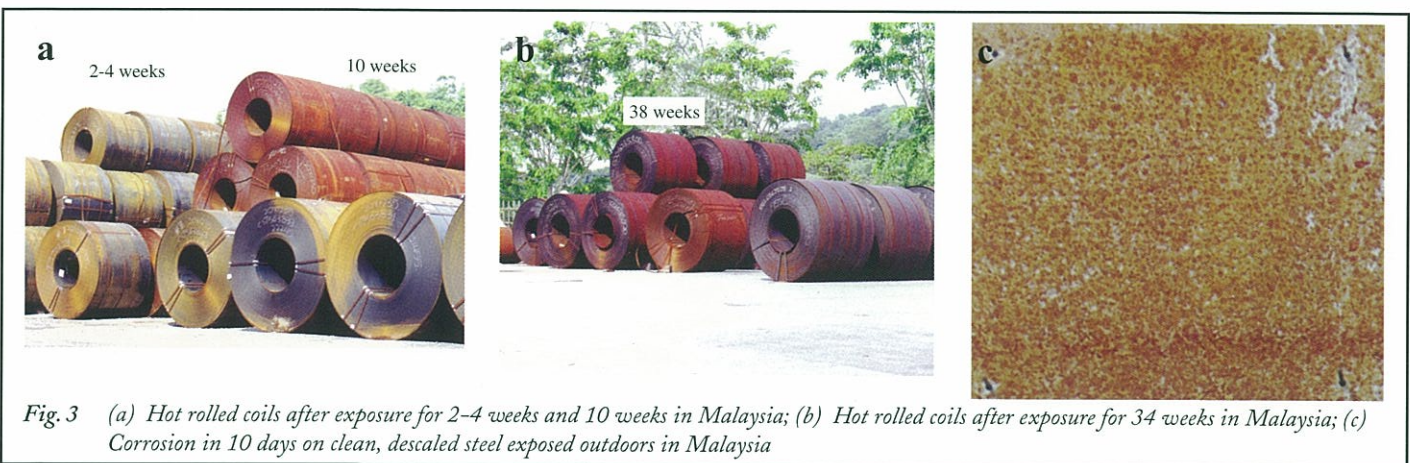
Fig. 3 (a) Hot rolled coils after exposure for 2-4 weeks and 10 weeks in Malaysia; (b) Hot rolled coils after exposure for 38 weeks in Malaysia; (c) Corrosion in 10 days on clean, descaled steel exposed outdoors in Malaysia

When exposed rolls are viewed from a distance, the above localized variations merge to produce an even patina. (There is a range of steels designed to never be painted, with the intent that they be used in applications where the eventual dark patina will appear as a natural effect, perhaps merging with the environment. Sometimes this works, depending on the skill of the architect.) With longer exposure the patina changes in color for the reasons given above. Examples are shown in Fig. 3a-b. When looking at these photographs, it should be taken into account that the coils were exposed in a tropical country six degrees from the equator, with a year-round average temperature of 27 °C and 70% average humidity. For pur-

poses of comparison, an exposed test sheet is shown in Fig. 3c.

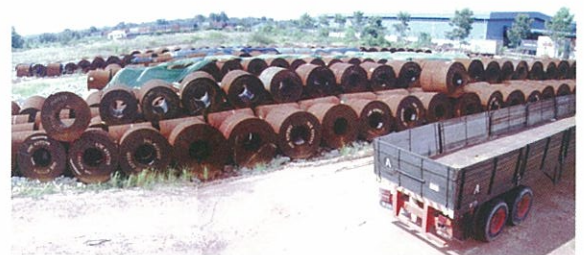
For an article devoted to damage during transit, there might seem to be undue emphasis on deterioration that occurs during land storage. On many claims for which we have been consulted, the sea voyage occupied only a small proportion of the insurance interval. The reason for this is the wide range of time intervals covered by marine policies. These can cover the voyage itself or might extend for long intervals on either side, during which the coils are simply sitting outdoors, sometimes in abysmal conditions (Fig. 4).

Fig. 4 Coil Storage: These coils weighed over 20 metric tons each and when placed on reclaimed land tended to sink, despite stones placed beneath. The land was subject to flooding. Some coils were placed on top, causing the ones beneath to sink further into the ground. Tarpaulins were placed over others, ensuring moist conditions round the clock. The insurance contract covered up to 60 days storage after the unloading from the vessel.

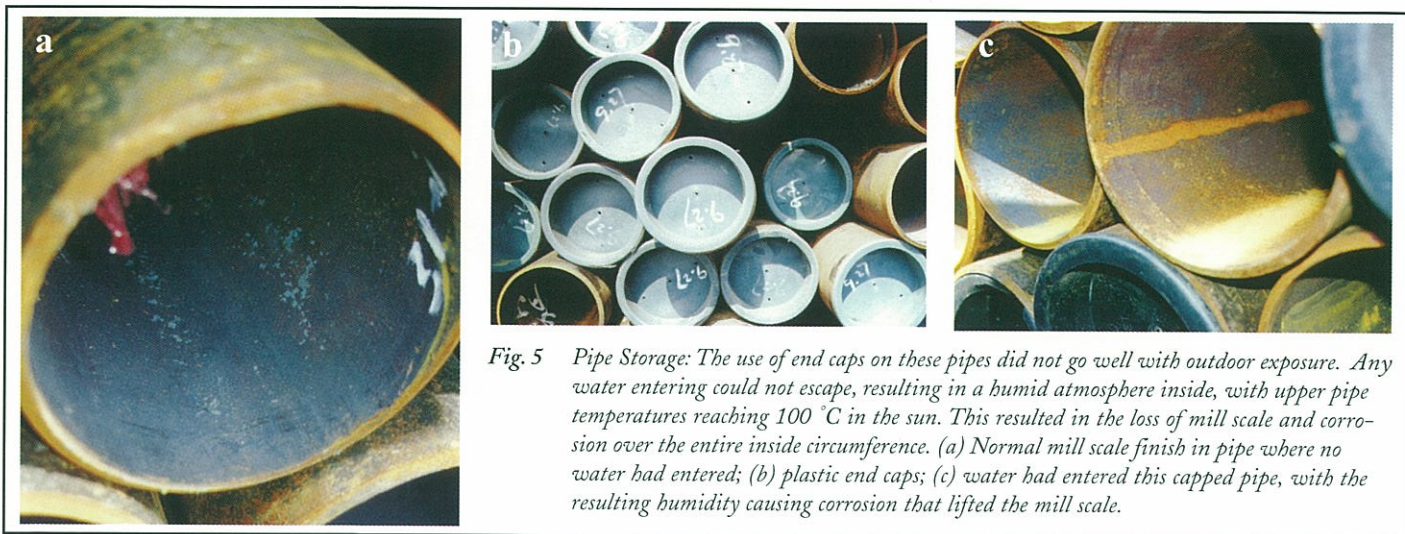
**Fig. 5** *Pipe Storage: The use of end caps on these pipes did not go well with outdoor exposure. Any water entering could not escape, resulting in a humid atmosphere inside, with upper pipe temperatures reaching 100 °C in the sun. This resulted in the loss of mill scale and corrosion over the entire inside circumference. (a) Normal mill scale finish in pipe where no water had entered; (b) plastic end caps; (c) water had entered this capped pipe, with the resulting humidity causing corrosion that lifted the mill scale.*

is not that much more complicated. Sometimes efforts to semi-protect the steel can worsen the situation (Fig. 5a, b, and c).

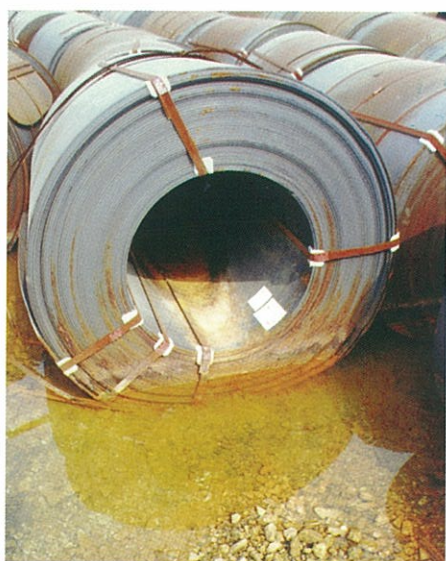
2. It is well known that with steel piles in water, corrosion is greatest at the splash zone, partly because of the optimum combination of wetting and availability of oxygen. Much the same applies to tropical corrosion where coils sit in pools of water (Fig. 6). At many of the storage sites we have visited, corrosion would have been less had the steel been totally submerged.

**Fig. 6** *Coils are sometimes stored outdoors in poor conditions.*

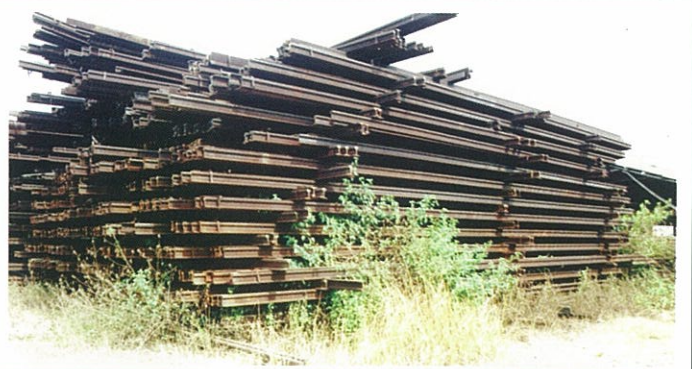
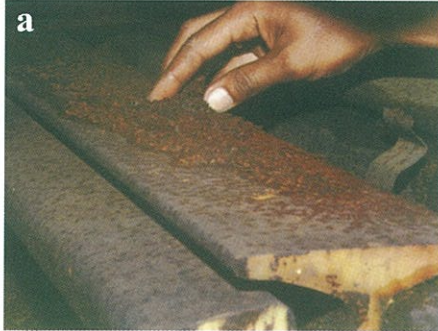
leads to an additional acceleration beneath continually wet deposits as a result of electrochemical effects (Fig. 7a, b, c, and d).

**Fig. 7** *Rail Storage: Steel rails for a long term project were imported into Malaysia and stored in the open. A large proportion were placed in one stack 6 m by 6 m by 5 m high. The rails from this and other stacks were used progressively, being taken from the tops of the stacks. After 17 months it was declared that the condition of the remaining rails in the large stack was so poor they were no longer acceptable. The rails in the smaller stacks were acceptable. Investigation revealed the size of the stack prevented the rails from drying out. Occasional rain, typically for a short time each day, kept the inside of the stack perpetually moist. Falling rust accumulated on horizontal surfaces, leading to deep pitting under the deposits.*

(a) Fallen rust accumulates on surfaces within the stack

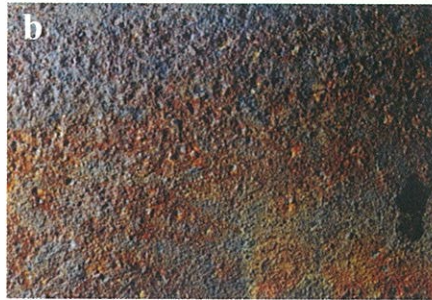
(b) Typical corroded upper surface from small stack

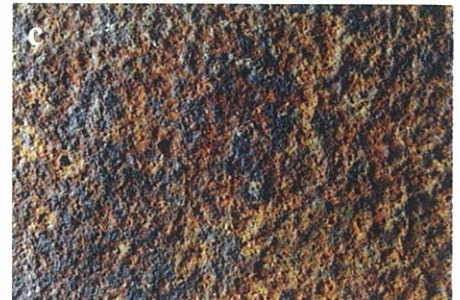
(c) Typical corroded upper surface from a large stack

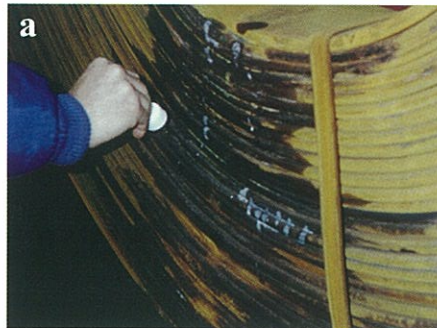
**Fig. 8** *Contamination by Acid: In this shipment from Europe, a survey prior to loading revealed seepage and a positive result for a chloride spot test. Note that these coils had been descaled. When the coils arrived in Malaysia six weeks later, there was unusually severe corrosion in the same areas of the coils. It was most probable the coils still conformed to the original specification, but the damage was then compounded by months of storage on swampy land, with tarpaulins holding moist air about the coils. Chemical analysis of the corrosion product revealed high fluoride levels. In retrospect, the positive test in Europe was probably from a pickling solution with HF content that had not been washed off.*

(a) The application of a silver nitrate swab produced a white precipitate, usually indicative of the presence of chloride ions. Courtesy of Unilex Maritime s.a.r.l., France

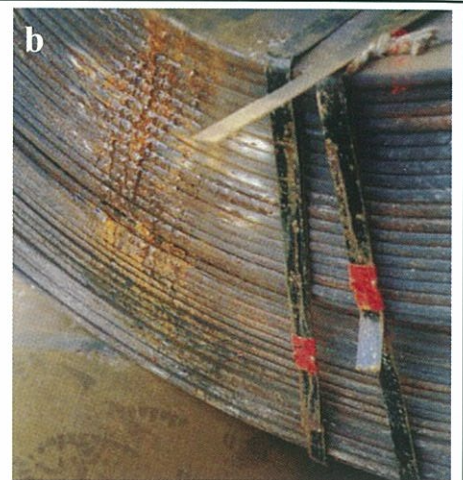
(b) Taken six weeks after survey in Europe. Courtesy of Link Survey (m) Sdn Bhd, Malaysia

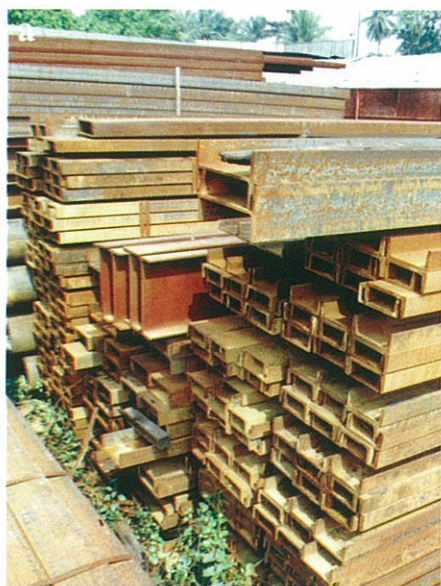
(a) Steel from Poland claimed to have been corroded during a voyage

**Fig. 9** *Prior Corrosion: Examination of this shipment of steel from Poland revealed that the corrosion was so severe it could not have occurred during the voyage. That is, the corrosion rate would have been in excess of that possible, even if it had been wet for the entire voyage. It was found that the steel had been stored under good conditions during the voyage and had not been wet. There were no other materials in the hold capable of accelerating corrosion. Inspection was carried out soon after arrival and storage corrosion after the voyage could not have been a factor. It was clear that the steel had been exposed to the elements for a long time prior to the voyage.*

This leads to the following corollary. If hot rolled steel from a voyage is found to have corroded to the extent that it no longer conforms to the standard under which it was manufactured, and there is no contamination other than wetting, then much of the corrosion had occurred prior to or after the voyage (Fig. 9).

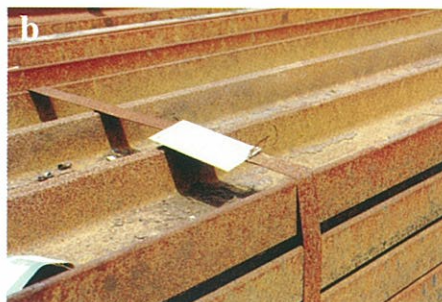
(b) Feature of this corrosion was that the mill scale had lifted on all surfaces, irrespective of orientation

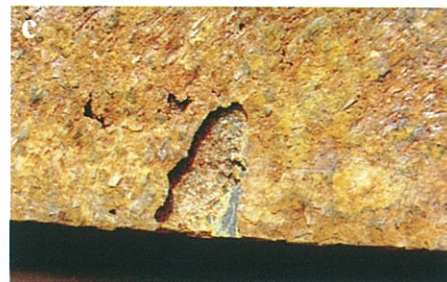
(c) Severe corrosion in the channel, to the extent that it could not have occurred during a single voyage

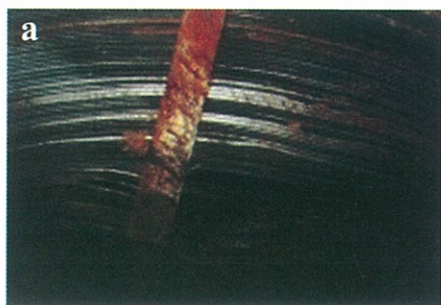
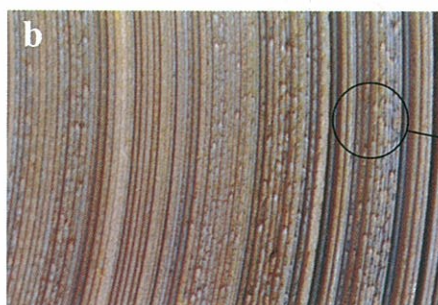
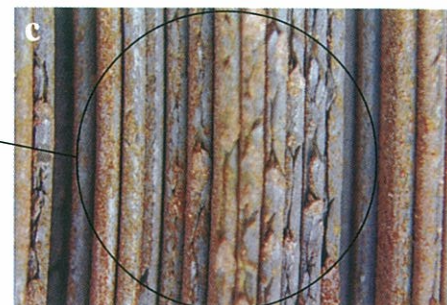
**Fig. 10** *Prior Defects: The explosion in world trade has increased the choices of sources of steel available to a manufacturer. There can be considerable saving in buying from a non-traditional source. However the more the sources the greater the possible range of defects. Steel from non-traditional sources can exhibit a range of quality problems which can complicate an insurance claim. For example, on a single shipment, there might be an unusual severity of rusting, together with serrated edges, coiling damage, and handling damage caused by poor strapping. (a) Burred edges on hot rolled coil, caused by rubbing during coiling. Such damage is not possible during transport; (b and c) serrated edges on hot rolled steel coil. This condition is a natural result of hot rolling, but it should be trimmed away at the steel mill prior to shipping.*

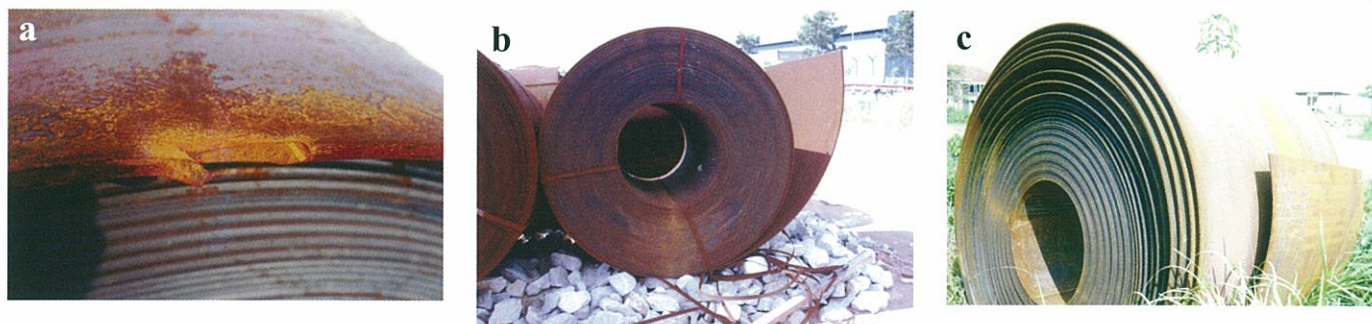
**Fig. 11** *Strapping: Strapping can be poor to begin with, or can deteriorate with handling and/or corrosion. If straps are unevenly tensioned, there will be excessive stress on the tightest. In turn each will fail. Straps are made of thin steel and a little corrosion can significantly weaken them. A tightly wound, tightly strapped coil is extremely strong, with each winding supported by its neighbors. However, once a coil is loosened and windings telescope, they are very vulnerable to damage. Unwinding alone, with no damage, can result in rejection because the coil will not fit into pipe making equipment and there is no way to recoil. (a) Edge damage. The orange color testifies to recent occurrence; (b) a coil with straps beginning to fail; (c) a coil with all straps broken, allowing the coil to unwind every time it is handled.*

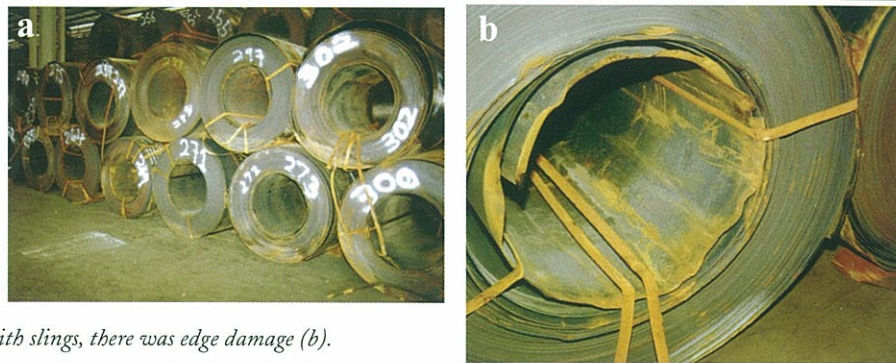
**Fig. 12** *Poor Strapping: (a) Coils of hot rolled steel from Russia, said to have suffered damage during handling during the voyage. Examination revealed that the damage had occurred during transport, but the coils had been rendered vulnerable to damage because of poor strapping at manufacture. The loose strapping resulted in the coils tending to unwind, with breaking of straps and further loosening. The coils were then able to telescope, and every time they were lifted with slings, there was edge damage (b).*

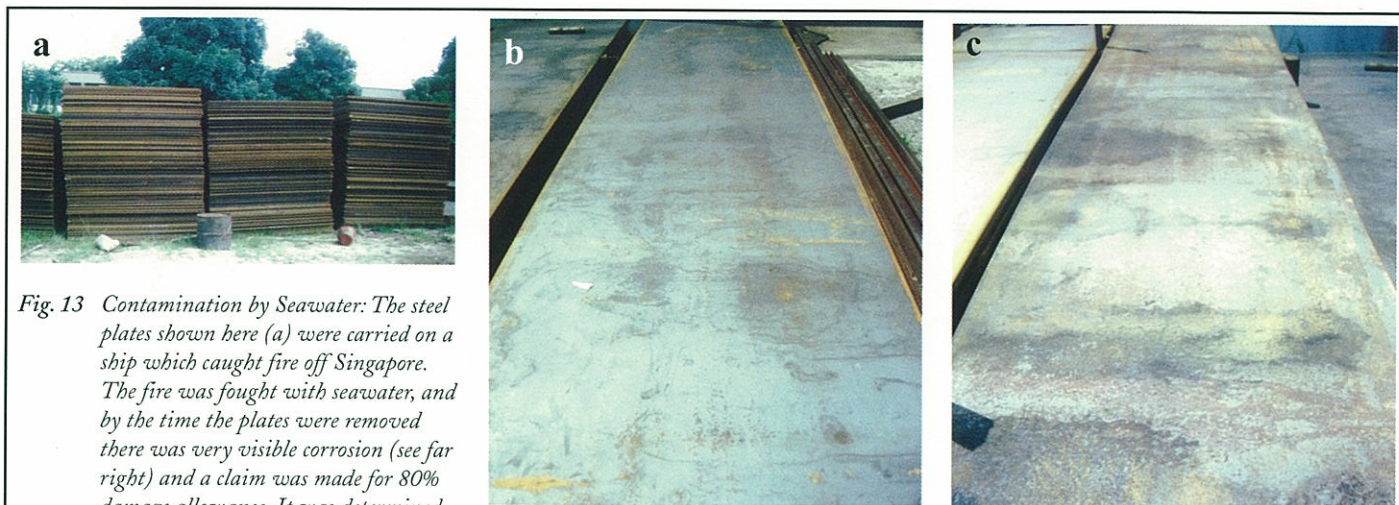
**Fig. 13 Contamination by Seawater:** The steel plates shown here (a) were carried on a ship which caught fire off Singapore. The fire was fought with seawater, and by the time the plates were removed there was very visible corrosion (see far right) and a claim was made for 80% damage allowance. It was determined that despite the long contact with sea water, the steel conformed dimensionally to the product standard under which it had been purchased. The plates were decontaminated and surface treated, at a cost of about 20% of the value of the shipment. The steel plate on the left (b) has a "normal" appearance, being mainly covered with mill scale. The plate on the right (c) has been in the hold of a ship while contaminated with seawater. While it looked bad, it still conformed to the original specification.

irrespective of how it looks. See Fig. 13 for a typical resolution. Knowledge of the other cargo and chemical analysis of corrosion products are necessary steps in failure analysis.

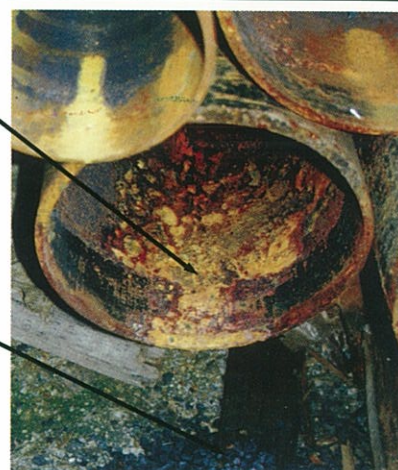
**Fig. 14 Contamination by Fertilizer:** This shipment of hot rolled pipe exhibited unusual corrosion upon discharge. Inquiries revealed there were fertilizer (ammonium chloride) and steelmaking additions stored above the pipe in the hold. The porous, granular steel-making addition stuck to the pipe, providing a reservoir for the fertilizer and moisture. It was likely that most of the corrosion occurred after the voyage while the pipes were stored outdoors and the insurance inquiries were being carried out.

Corrosion pitting inside of pipe, revealed after removal of porous steelmaking material seen below.

Steelmaking addition that had been lying inside the pipe. Found to be moist and contaminated with ammonium chloride.
